UVC:

Florida Hospital Puts HVAC Maintenance Under A New Light

HVAC system downtime during coil cleaning can compromise humidity and temperature control, potentially leading to air quality or comfort problems. Florida Hospital has found that high-output ultraviolet-C lights installed in the AHUs reduce or eliminate coil-cleaning programs — yielding ongoing energy savings, a reduction in HVAC system maintenance, and the elimination of cleaning chemicals. The facility also reports IAQ and infection control benefits as the regimen continues.

BY FIROUZ KEIKAVOUSI

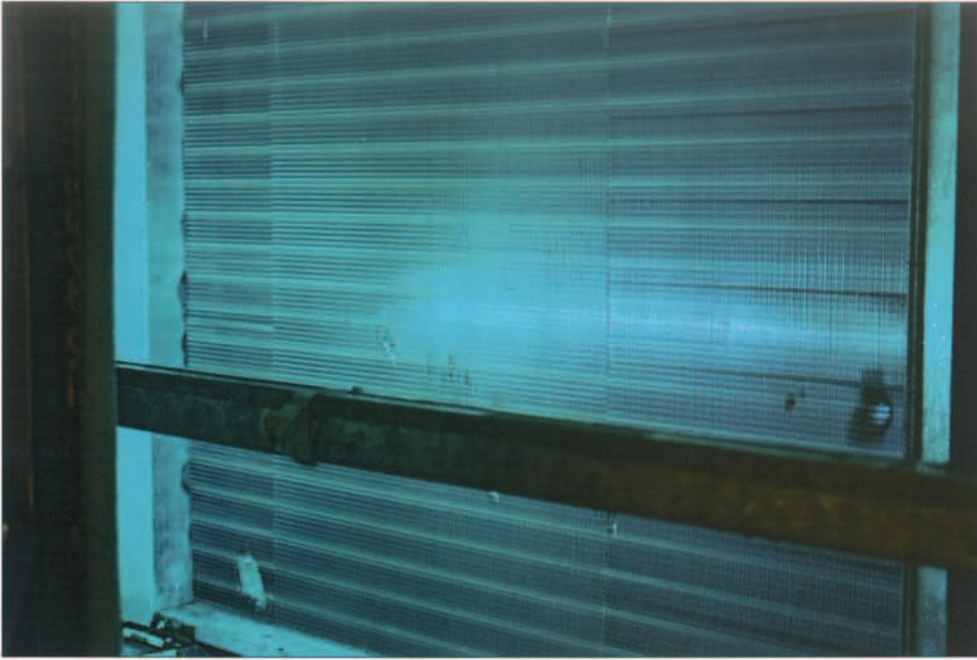
A control unit in one of the early tests, this air handler was later equipped with UVC.

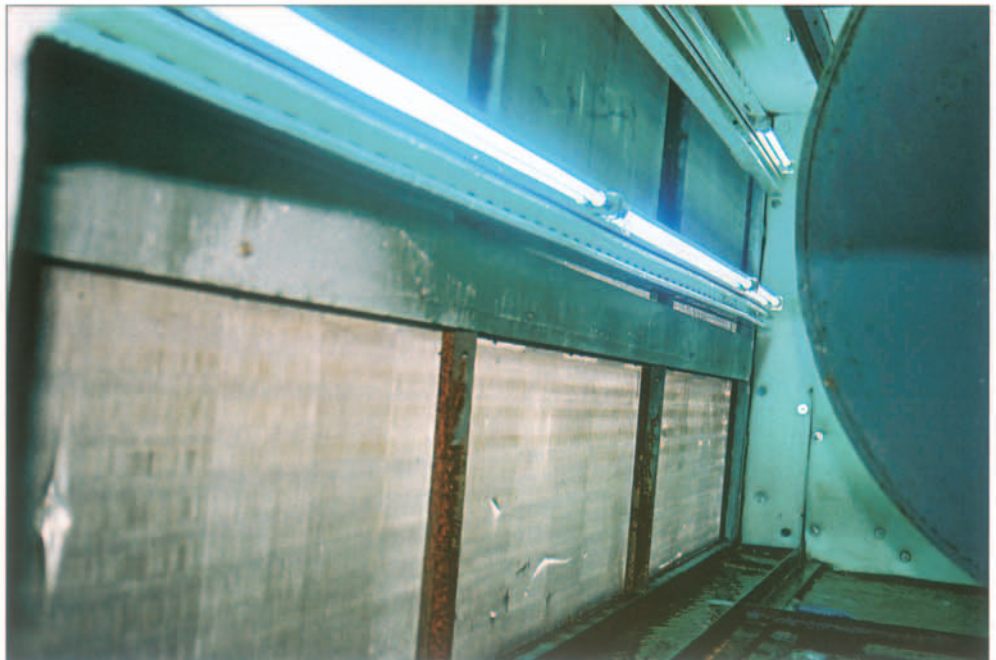
A recent UVC installation with a large coil.

After reviewing these initial results, the hospital administration agreed to expand the use of UVC. By the beginning of 2004, more than 100 AHUs in seven FH campuses were outfitted with the lights (Table 1), as well as some ceiling-mounted and portable air circulating units. To obtain desired results in the AHUs, we generally follow the manufacturer's recommended guideline of 24 in. of UVC tube length for every 4 sq ft of coil face area.

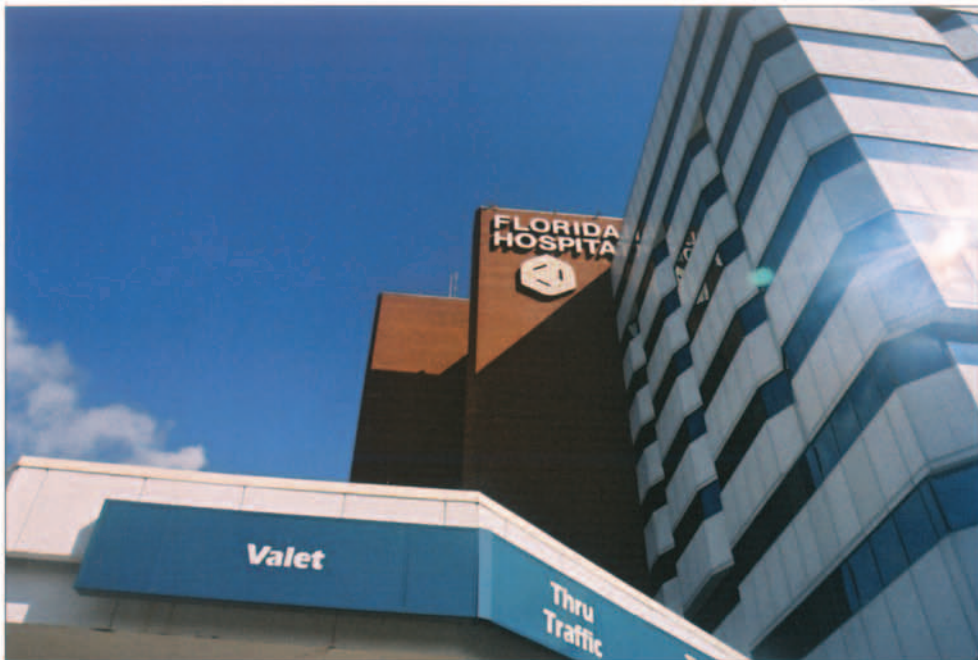
UVC lights have been used in facilities throughout the Florida Hospital system.
